Removing the Transmission from the 900C

Roger Chaney
Technical Editor

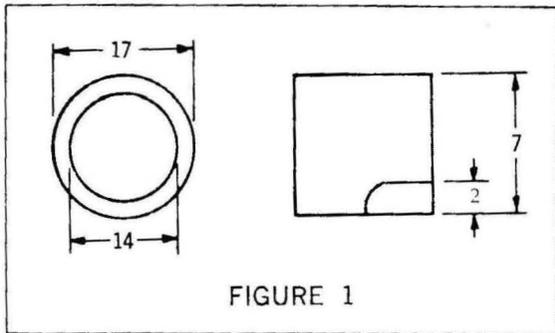
FIGURE 1

After removing the power package (engine and transmission), you will need to use a special tool set that you can make with simple shop tools. These tools for the clutch consist of 3 small sleeves and 3 machine screws. The sleeves should be as shown in figure 1. Along with this sleeve, use a thin steel washer 17mm o.d. with a 6.5mm hole. You may need to use a rat-tail file to cut the hole slightly oval for the bolt to center. For the bolt, use an M6x12 bolt used to hold door hardware in place and other jobs on lots of Porsches. Porsche part numbers for the bolt are 900.119.019.02 or 900.067.008.02.

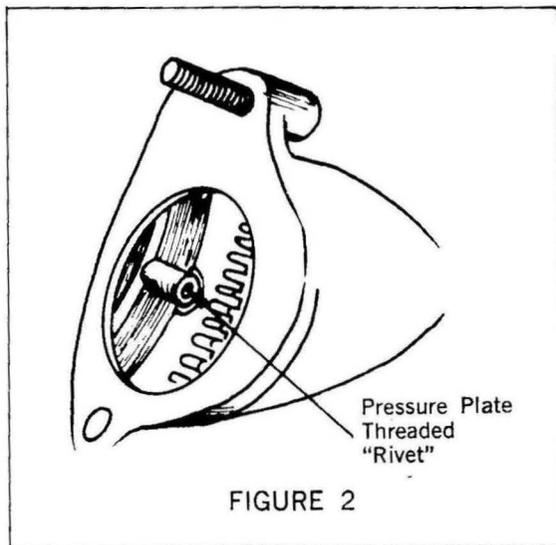
FIGURE 2

To use your tool, remove the starter and rotate the flywheel until you line up one of the pressure plate "rivets" (see figure 2). Assemble the sleeve

"Removing the Transmission from the 900C", Figure 2, p. 19, May 1972, is printed upside down. According to author Chaney, the drawing is usable only if it is oriented properly.

and washer over the rivet and screw the bolt in until it contacts the washer. Rotate the flywheel and repeat at the other two "rivets". Continue rotating the flywheel and tighten each bolt with the appropriate hex head wrench (Allen type wrench) a little at a time until the clutch has been pulled enough so the clutch throw-out bearing can be rotated by 90°. This will allow the work to slide over the flat sides of the bearing housing and the transmission will now come off easily. 5/72

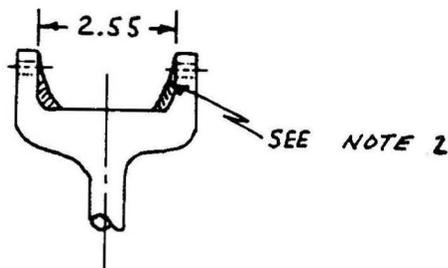
AXLE
and
SHAFT

2. Shaded material must be milled off or counter-bored to provide a flat surface for retaining rings. Alignment is critical. A little misalignment can mean a lot of vibration.

3. This dimension must be consistent with the 2.55" of the flanges when assembled.

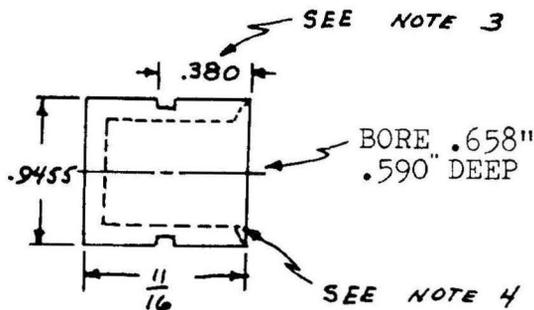
BUSHING

The accompanying sketches should provide sufficient data such that any good machinist can make them up. The Spicer seals are retained. The bushings are made of axle steel with a Rockwell C of about 35-40. Since relative motion of the cross and bushing is a minimum, I anticipate no problem from galling. Steel was chosen over phosphorbronze because of the skinnyness of the axle ears. I must give credit for the design of the bushings to an elderly machinist in the Dallas area.

4. This corner must be chamfered so that bushing will bottom on end of cross.
